# Field Report

## DeSoto National Wildlife Refuge

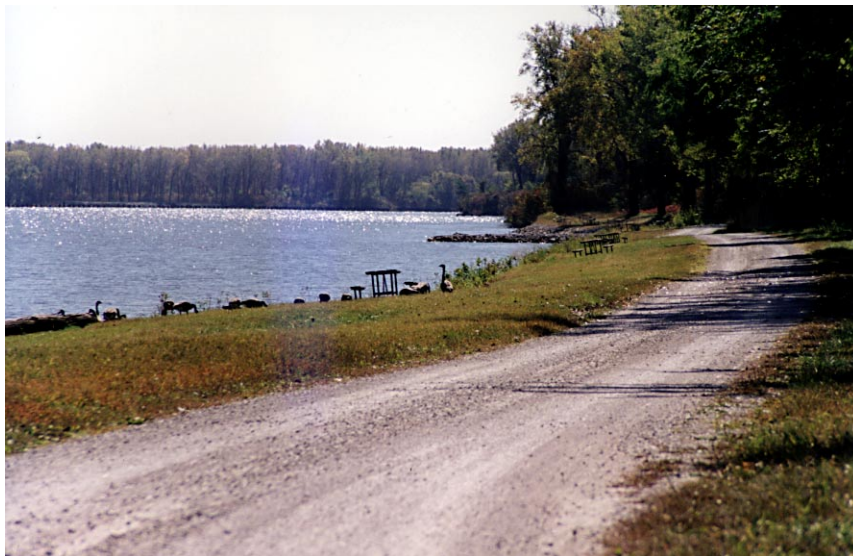
#### Unpaved Road Within DeSoto National Wildlife Refuge

- **Unpaved Roadways** – Approximately six of the 12 miles of roadways on the Refuge are unpaved. There is a concern amongst Refuge staff that dust from the unpaved roadways generally detracts from a visitor's experience and creates a safety hazard as vehicles are frequently pulled over to the side of the road, (often without a shoulder), and create a potential hazard for passing cars.

- Placing portable changeable message signs along U.S. Highway 30 during periods of high congestion. These signs would warn motorists of slow moving traffic and encourage cautious driving.
- Diverting traffic to the south entrance. During periods of peak congestion on U.S. Highway 30, vehicles could be directed to enter the Refuge at the south entrance, avoiding the traffic on Highway 30.
- Pave the approximately six miles of what is now gravel roadway.
- Pave approximately six parking lots within the Refuge, each with an estimated average capacity of 30 cars.
- Pave approximately two miles of dirt trails.
- Pave pull-off areas, both internal to the refuge and (perhaps) along U.S. Route 50 as well.

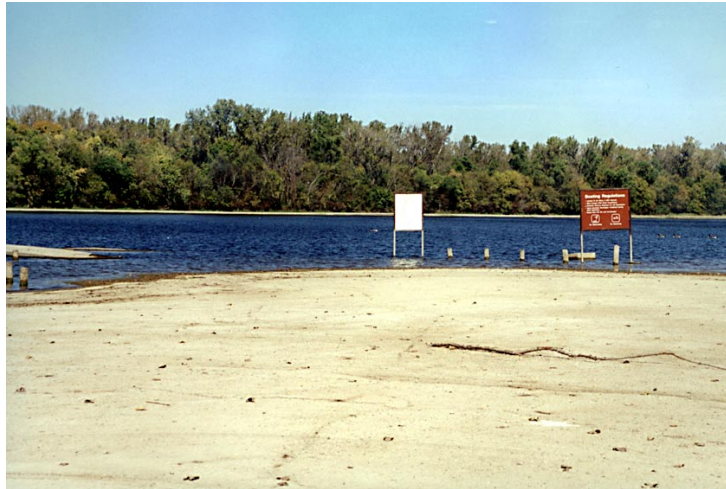
- **Flooding** – Parking lots have been closed due to flooding along with boat access sites to DeSoto Lake. Hiking trails have also been closed due to flooding. Closures of parking lots, boat access and trails have lasted up to several months resulting in a significant inconvenience for visitors.

## Flooded Boat Landing at DeSoto National Wildlife Refuge

Refuge management would like to raise the elevation of roads, trails, parking areas and boat accesses that are most commonly effected by flooding.

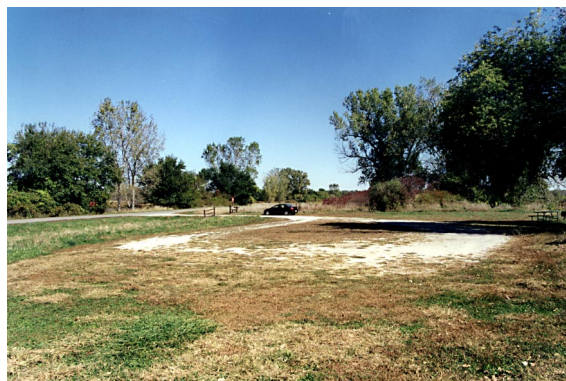
- **Unpaved Parking Lots and Pull-Offs** – Many of the parking lots within the Refuge are not paved. Refuge staff indicated that paved parking areas would better accommodate visitors who park within the grounds of the Refuge. Additionally, there are a limited number of areas where motorists can pull off to the side of the road. All these areas are unpaved within the Refuge.

## Unpaved Parking Area at DeSoto National Wildlife Refuge
